Manhole Inspection Summary

Manhole # S37GG_020MH

Insp Date: **3/21/07 12:41 PM**

Location Address: **1224 HOMEWOOD AVE**

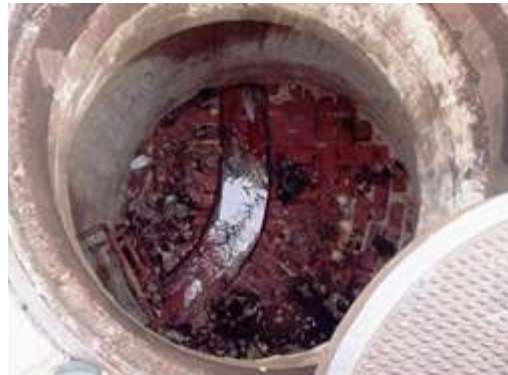
Top View

Evidence of surcharge - Bench debris.
Corroded steps.

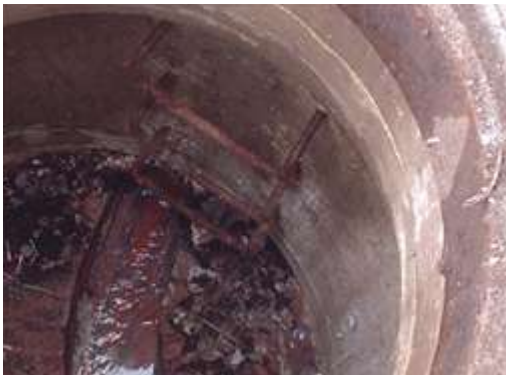
Defect

Barrel infiltration.

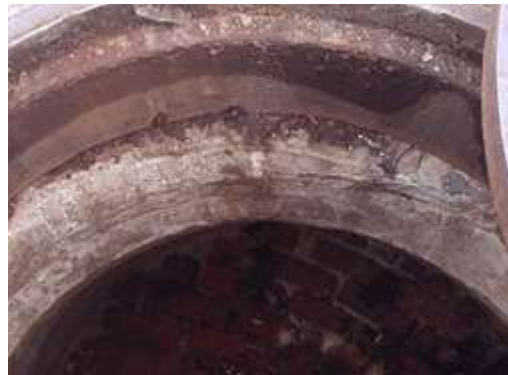
Defect

Frame leaks. Frame offset. Corbel and
Barrel infiltration.

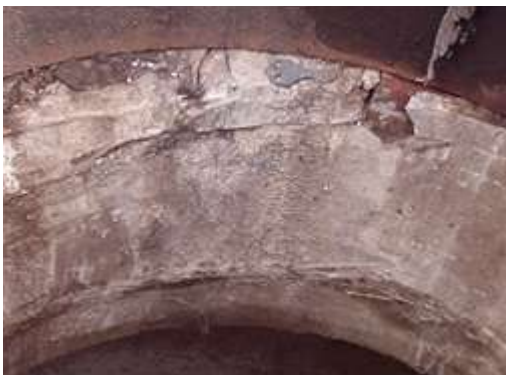
Defect

Frame leaks. Corbel infiltration.

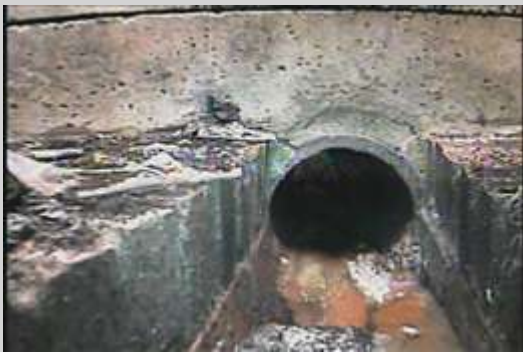
8 in. Circular Gravity Sewer Pipe Out @ 12 O'Clock

Deposits: ☐ None ☒ **Mud** ☐ Sludge ☒ **Debris** ☒ **Grease**

Silt Depth: **0.5** (in.) Deposits Extent: **Light**

Infiltration: **Evidence** Pipe Seal Cond: **Cracked**

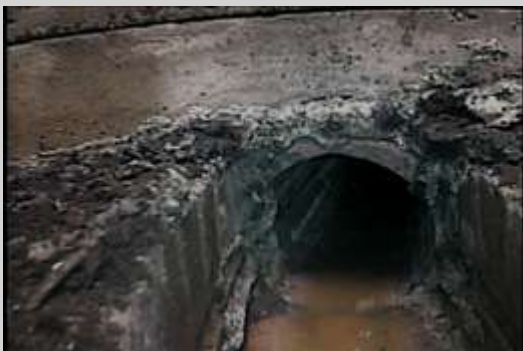
8 in. Circular Gravity Sewer Pipe In @ 8 O'Clock

Deposits: ☐ None ☐ Mud ☐ Sludge ☐ Debris ☒ **Grease**
